DL12 Limit Assembly Gear Spacing

Problem description: If the open and close position are changing randomly when the gate is operated the possible cause can be limit assembly gear spacing. To inspect and adjust this follow the steps below.

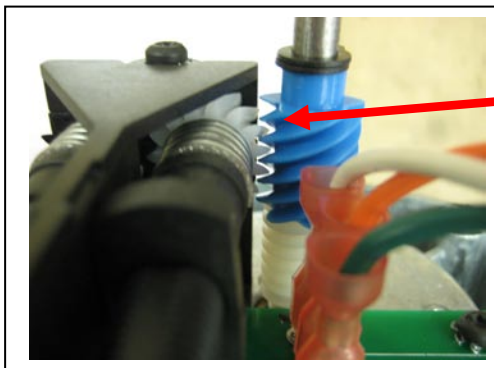
The gap between the blue and white
gear

1. Disconnect the actuator cable from the control board.
2. Remove the 5 bolts holding the rear cover on the actuator. 5/16 head size.
3. Inspect the spacing between the blue and white gear.
4. Loosen the 4 screws to allow the limit assembly to slide over against the blue gear.
5. Once limit assembly white gear spacing is adjusted tighten the 4 screws.

NOTE: Do not apply pressure to the limit assembly just slide over until space is reduced and tighten screw.
